# NDE Associates, Inc.

## ECT for detection of Axial ODSCC: Case Study NDE 02-01

**Problem:** Detection of Axial SCC under supports in Inconel Tubes. Tube size  $\frac{3}{4}$  inch OD x 0.049 inch t (19 mm OD x 1.25 mm t)

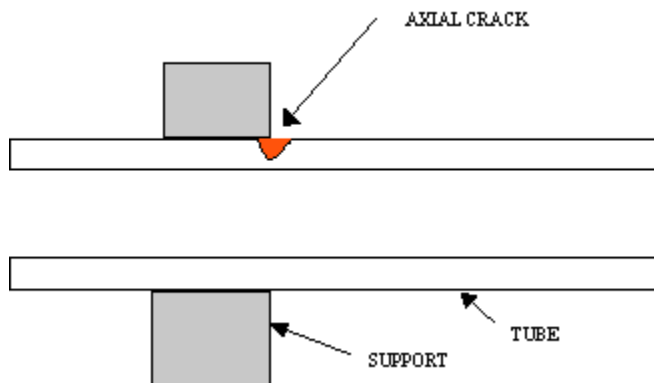
NDE Associates, Inc. conducted Eddy Current Test of all the tubes. ECT test detected OD defect signals at the 2<sup>nd</sup> and 3<sup>rd</sup> supports in several tubes.

Figure 1. Axial ODSCC at the edge of support plate

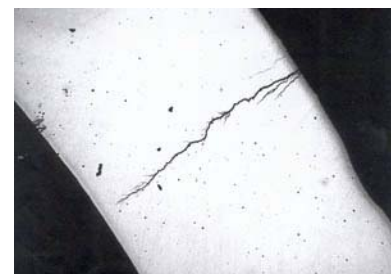
**Metallurgical Tests:** Sample tubes were pulled for metallurgical tests. The cracks were so tight that preliminary visual and Liquid Penetrant tests showed no indication of damage. Metallographic sectioning was performed to investigate the defect and determine the damage mechanism. Metallographic sectioning showed tight OD stress corrosion cracks (SCC) at the edge of supports. The length of the crack was 0.060 inches (1.2 mm). The width of the supports is  $\frac{3}{4}$  inch (19mm).

Figure 2. Cross-section of the crack
