# Ultrasonic Detection of Hydrogen Attack in Steels<sup>☆</sup>

A. S. Biring,\* M. L. Bartlett,\* and K. Kawano\*\*

## ABSTRACT

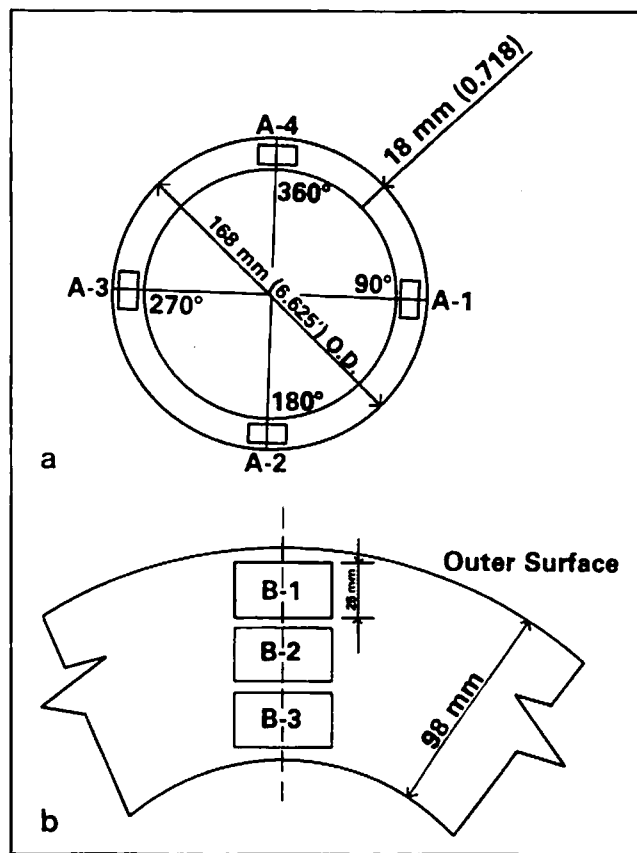
FIGURE 1. Schematic illustration of sample locations taken from a pipe (Set A) and a vessel (Set B). (a) Samples A-1 through A-4 with hydrogen attack were cut at the same axial location on the pipe. Sample A-5 was cut from the same pipe, but at a different axial location with no hydrogen attack. (b) Samples B-1 through B-3 were cut through the outside surface, midthickness, and inside surface of the vessel, respectively.

Ultrasonic tests were conducted on two samples received from two petroleum-related confidential sources. One set of five samples, supplied from one source and identified as Set A, was cut from a pipe with a 16.8-cm (6.625-in.) OD and 1.8-cm (0.718-in.) thickness. Four of the samples (A-1 through A-4) with hydrogen attack were cut from 90-, 180-, 270-, and 360-degree locations of the pipe, respectively. The fifth sample (A-5) was from another pipe location with no hydrogen attack. A second set of samples, identified as Set B, was cut from a 98-mm- (3.85-in.)-thick vessel made out of ASTM<sup>(2)</sup> A204 Grade A steel. Three samples were made (B-1 through B-3); each sample was a 25-mm-

(1-in.)-thick piece cut across the thickness of the vessel wall from the OD through the ID (see Figure 1).

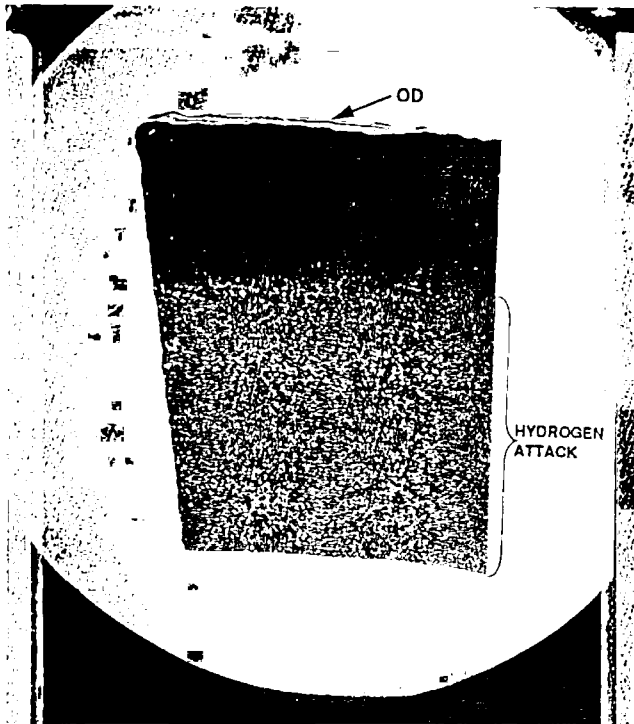
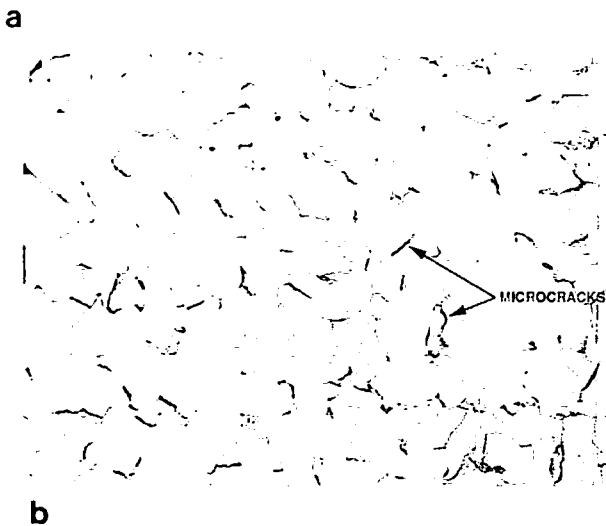
FIGURE 2. Micrographs showing hydrogen attack in Set A samples. (a) Sample A-2 shows damage through about two-thirds of its thickness. (b) Microcracks, about 50- $\mu\text{m}$  long, are shown at the inside surface.

**Metallography** — Hydrogen attack in the specimens was confirmed by metallography. Micrographs taken on Samples A-1 through A-4 showed microcracking and decarburization. Figure 2(a) shows the micrograph (4X magnification) for Sample A-2 (180 degrees) in which two-thirds of the thickness from the ID was attacked by hydrogen. Microcracks and decarburization are visible (200X magnification), as shown in Figure 2(b). The microcracks at the ID were approximately 50  $\mu\text{m}$ . Metallurgical investigation revealed the hydrogen attack in Set A was in an advanced stage. A micrograph of Sample B-3 (ID) (see Figure 3) displayed cracks of the order of 25  $\mu\text{m}$  produced by hydrogen attack. Metallurgical investigations showed isolated microcracks on a few grain boundaries in Sample B-3 compared to Samples A-1 through A-4 and established that the hydrogen attack in Sample B-3 was in an early stage. No hydrogen attack was evident at the OD (Sample B-1).

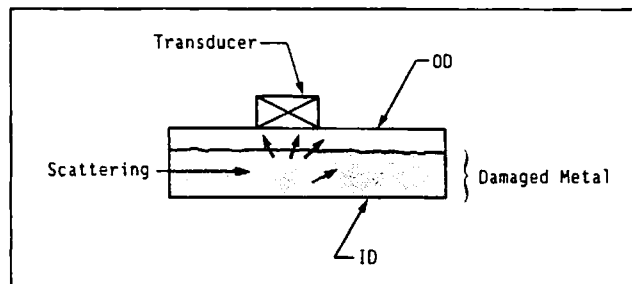
FIGURE 4. Test configuration to measure ultrasonic back-scattering caused by discontinuities within the material.

**Back-Scatter** — Ultrasonic back-scatter is a method in which the ultrasonic waves scattered from within a material are analyzed. Figure 4 shows the concept of measuring back-scattered signals. Back-scattering occurs from the grains because of impedance mismatch at the material's grain boundaries. Back-scattering increases with frequency, so these measurements are usually conducted at high frequencies such as 10 MHz.

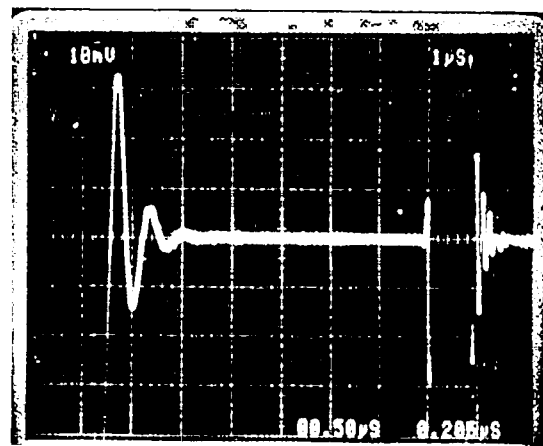
FIGURE 5. Back-scattering from hydrogen-attack measurements using a 10-MHz transducer. (a) Back-scattering from Sample B-1 cut from the outside surface with no hydrogen attack. (b) Back-scattering from Sample B-3 cut from the inside surface, which had hydrogen attack.

Results of back-scatter on the samples in Set A, given in Table 4, show that the back-scatter amplitude (relative) increased from 2 mV in the sample with no hydrogen attack to an amplitude range of 13 to 24 mV on samples attacked by hydrogen. Results of back-scatter measurements on samples in Set B, given in Table 4, showed that the back-scatter amplitude increased from 2 mV at the OD, where there is practically no hydrogen, to 20 mV at the ID. Figure 5 presents the oscilloscope traces of the amplitude at the OD and ID, which definitely show the strong increase in back-scatter at the ID.

at the OD to 3.2 db at the ID, which could indicate damage. Attenuation measurements, however, can result in false indications if the ID surface is pitted and scatters ultrasound. The most prominent results on the samples in Set B were determined from the back-scatter measurements, which displayed a significant increase in amplitude at the ID — about 10 times over the OD.
